Entrapment in Garage Kills One Firefighter

San Francisco, California

75 Everson Street
San Francisco, California

March 9, 1995

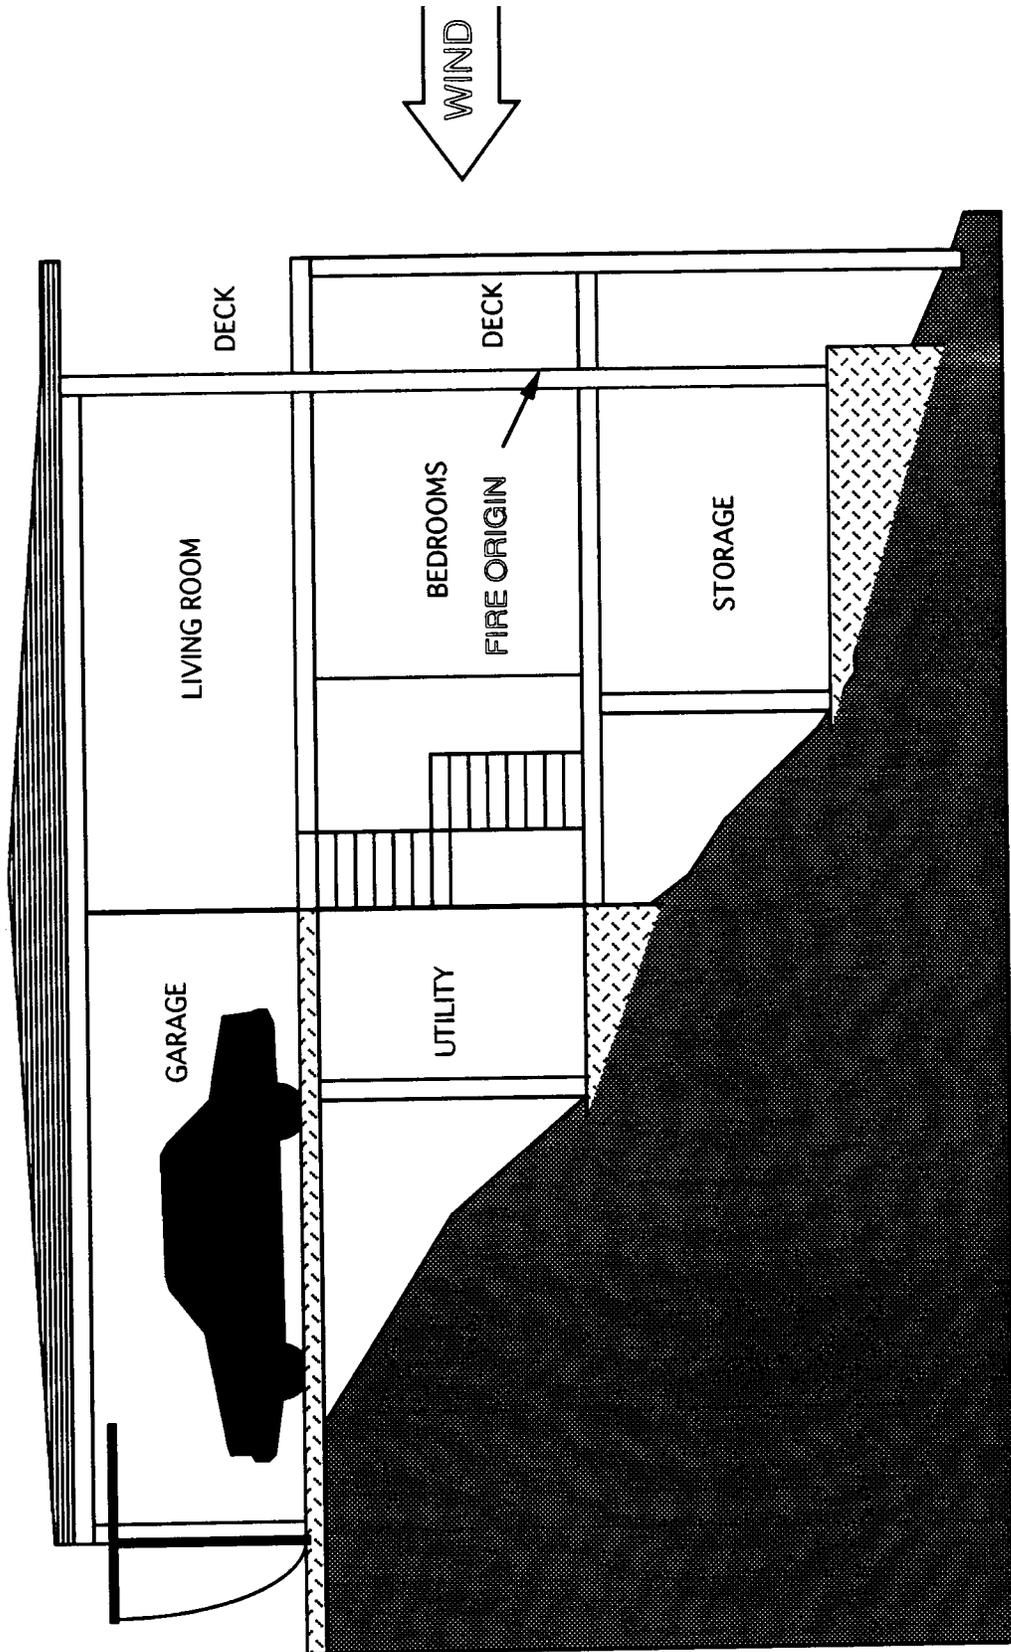
Figure 1a

The house had three levels (see Figures 1a and b). The lower level was only accessible from the back yard and was used exclusively for storage. The middle level had three bedrooms, each with a view to the south. A utility room ran the width of the house on the north side. Two full bathrooms flanked the open center stairway (Figure 3).

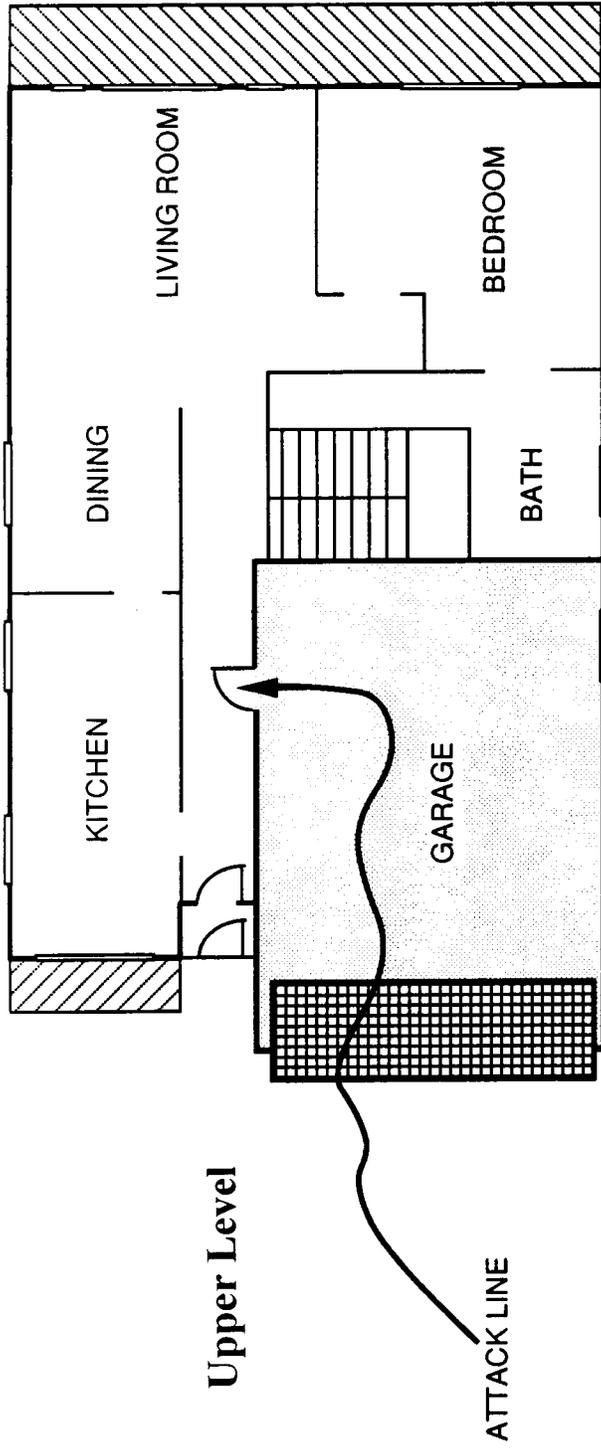
Figure 2

The upper floor was the only level visible from the street (Figure 2). On this level, the living room and the master bedroom faced to the south. The garage was north of the master bedroom, while the dining room and kitchen were north of the living room. Between the kitchen and the garage was an entry hall leading to the front door of the residence. The two upper levels contained about 2,050 square feet of living space.

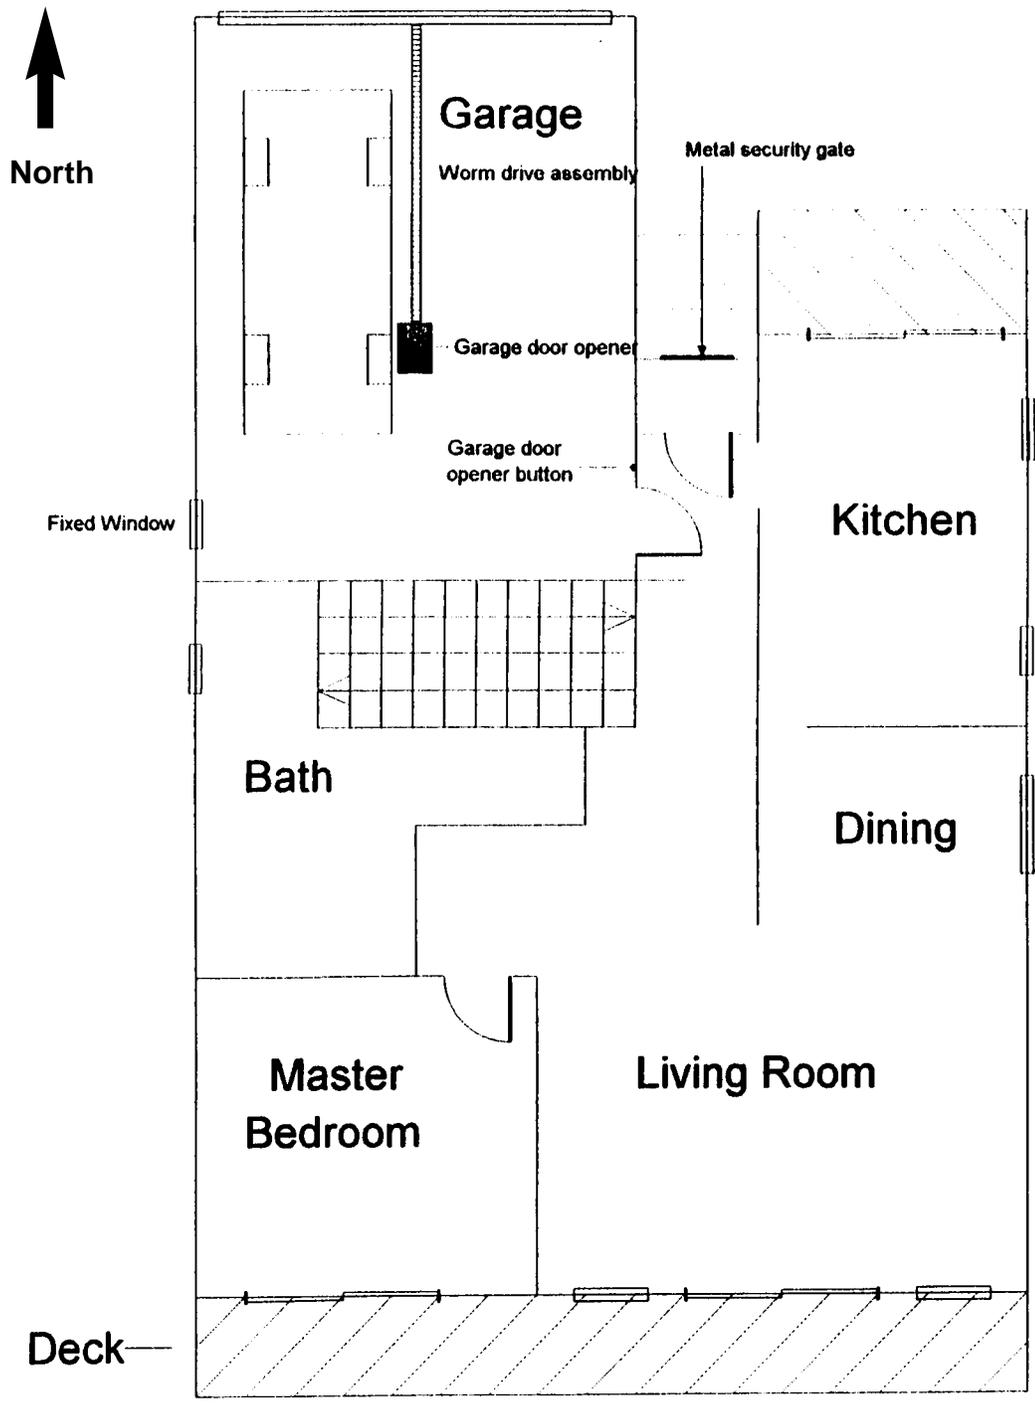
Figure 5

The garage door was a single panel, constructed of 3/8 inch plywood with 2x4 and 2x2 framing (Figure 4). This door was 16 feet wide, 7 feet high and weighed about 250 pounds. Connected to the door was a screw drive type mechanical garage door opener. The opener could be activated by a wall-mounted push button near the door leading to the entry hall (Figure 5) or either of two remote controls. The remotes were kept in the family cars.

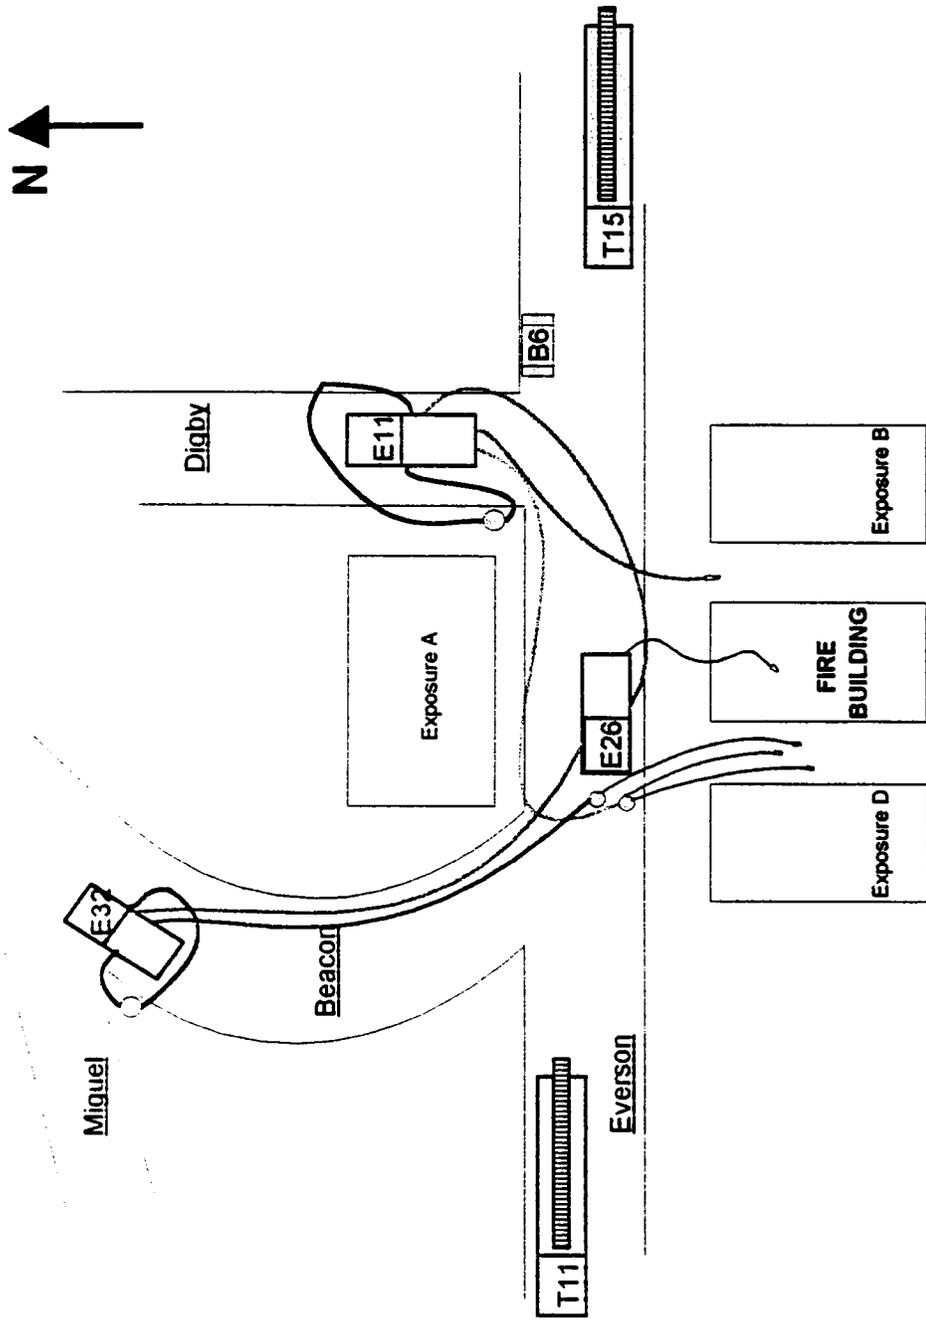
Figure 6

SFFD Engine 26 arrived on the scene at 12:59:10 and reported a “working fire.” The pump operator pulled slightly past the fire building in an effort to give his officer a look at three sides of the scene (Figure 6). A few blocks away Truck 11 had just gone back in service from another call and heard the Engine 26 report. Truck 11 told the Communications Center that they would respond to 75 Everson Street.

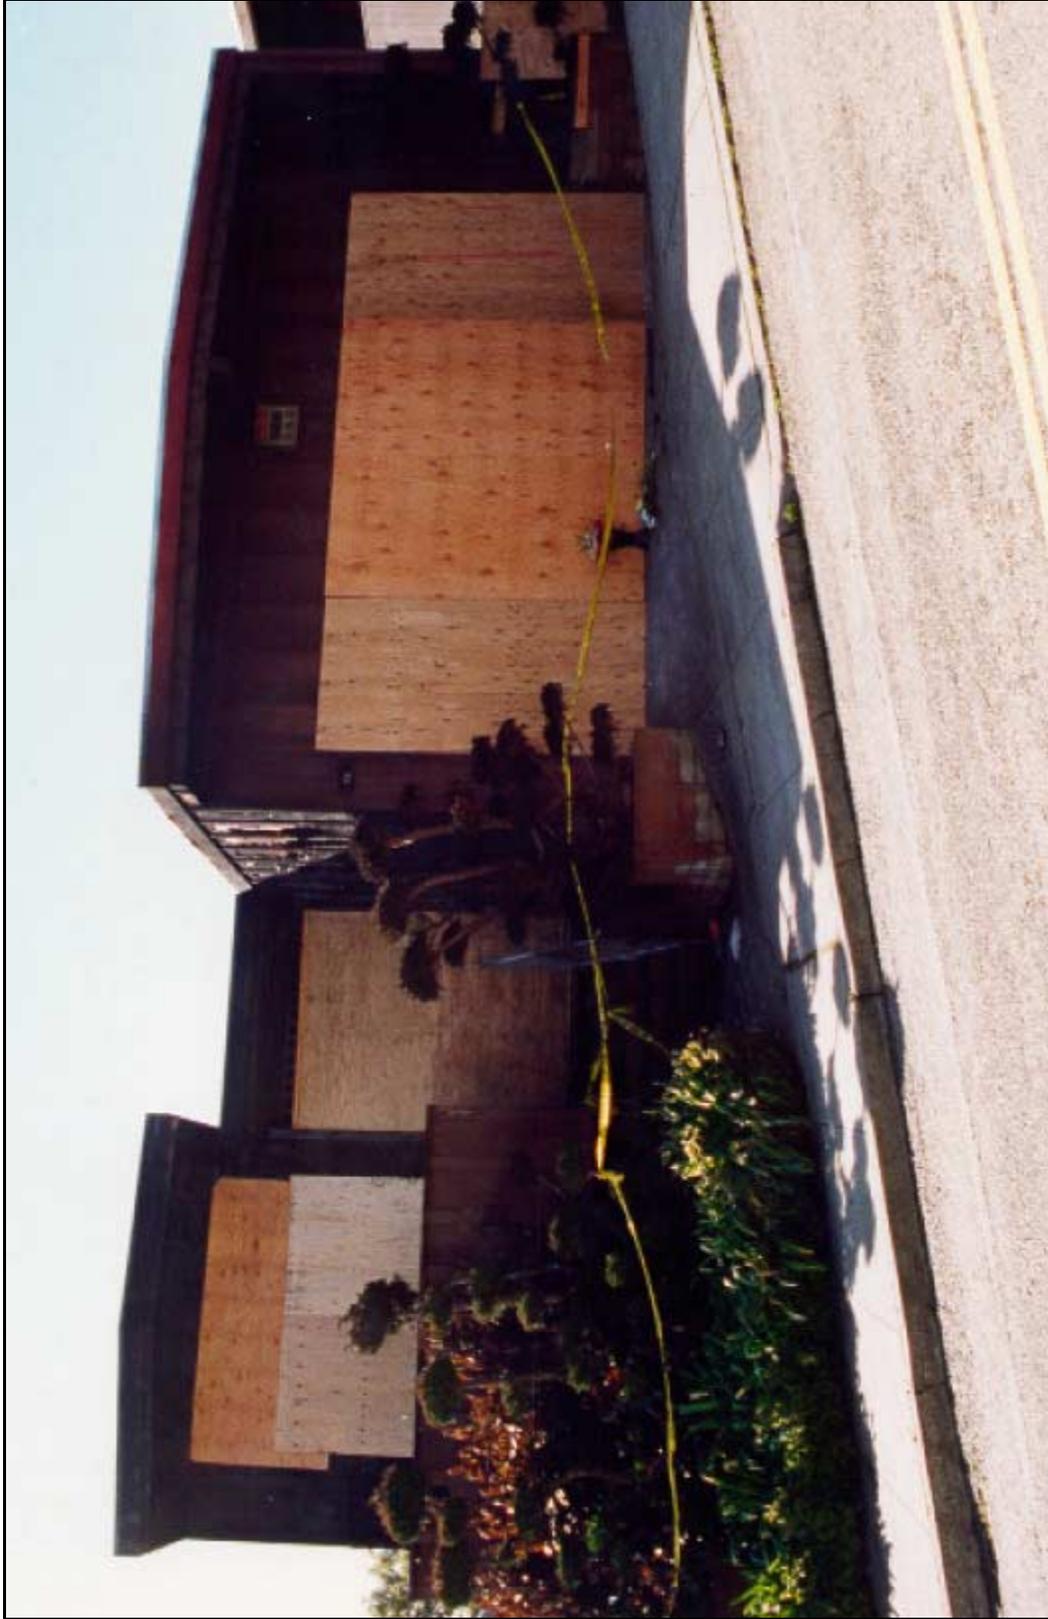
PHOTOGRAPH 1 The front of the house. The garage is to the right, the entryway door is in the center and the kitchen is to the left side of the photograph.
